REGIONAL DISTRICT OF  
BULKLEY-NECHAKO

GEOTECHNICAL ASSESSMENT  
LOWER VIEWMOUNT ROAD  
SMITHERS, BC

DATE PREPARED: DECEMBER 2006

PROJECT No: KX04813

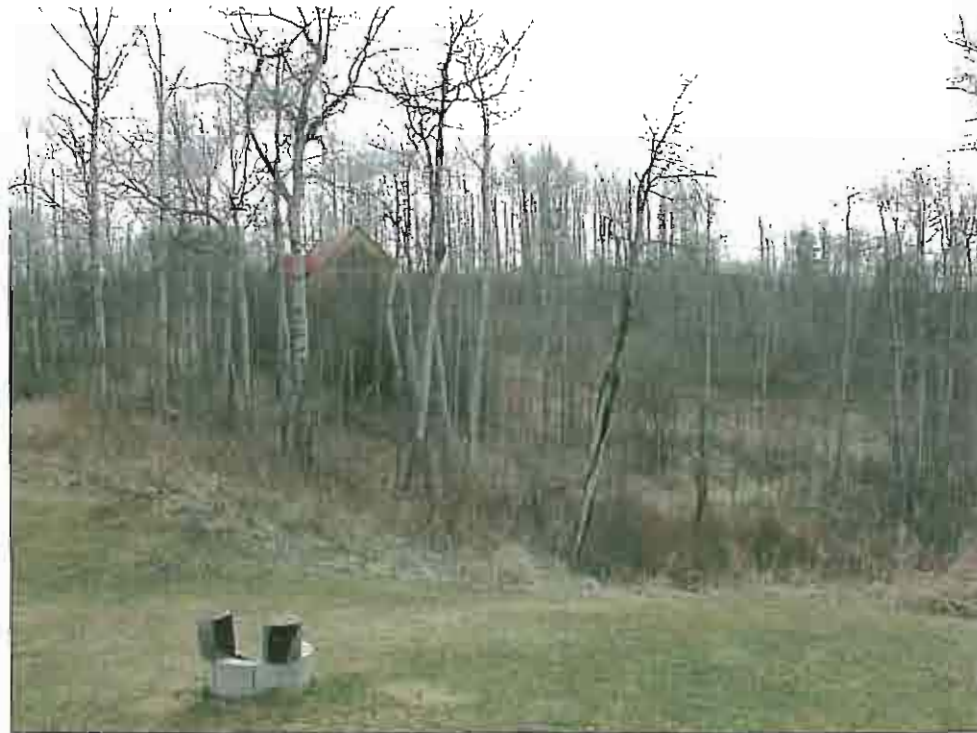
**Photo 32:** View east from 559 towards 485 across what is interpreted to be the possible northwest end of the main scarp of the landslide. Septic lagoons for 485 and 559 are on slope to right of photo.

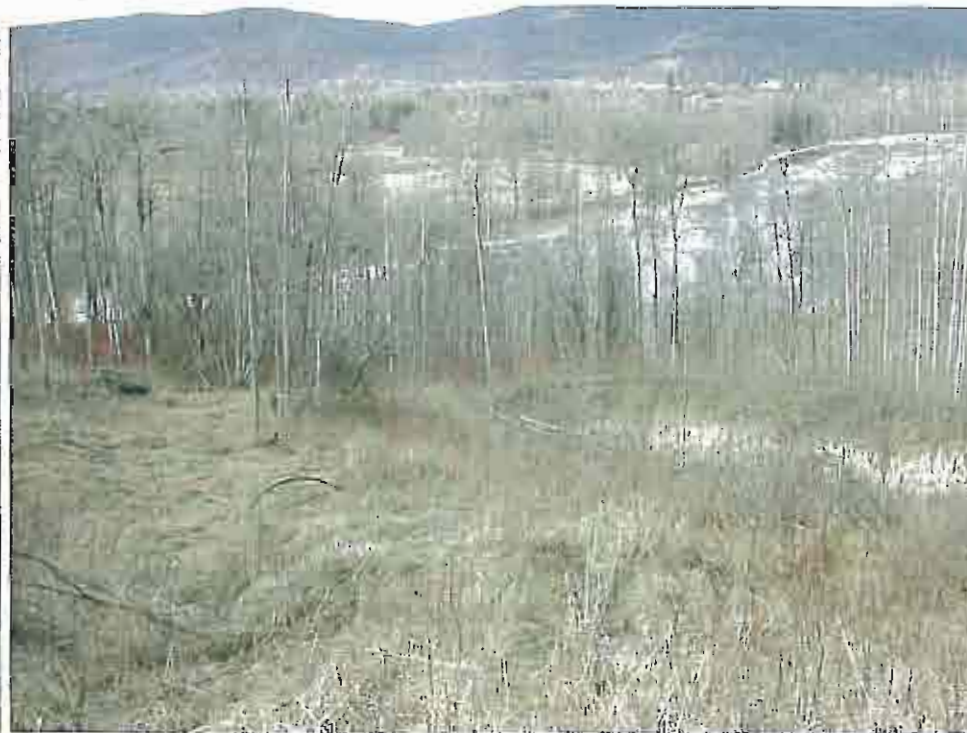
**Photo 33:** View south at lagoon constructed on bench (graben?) on slope below 559.

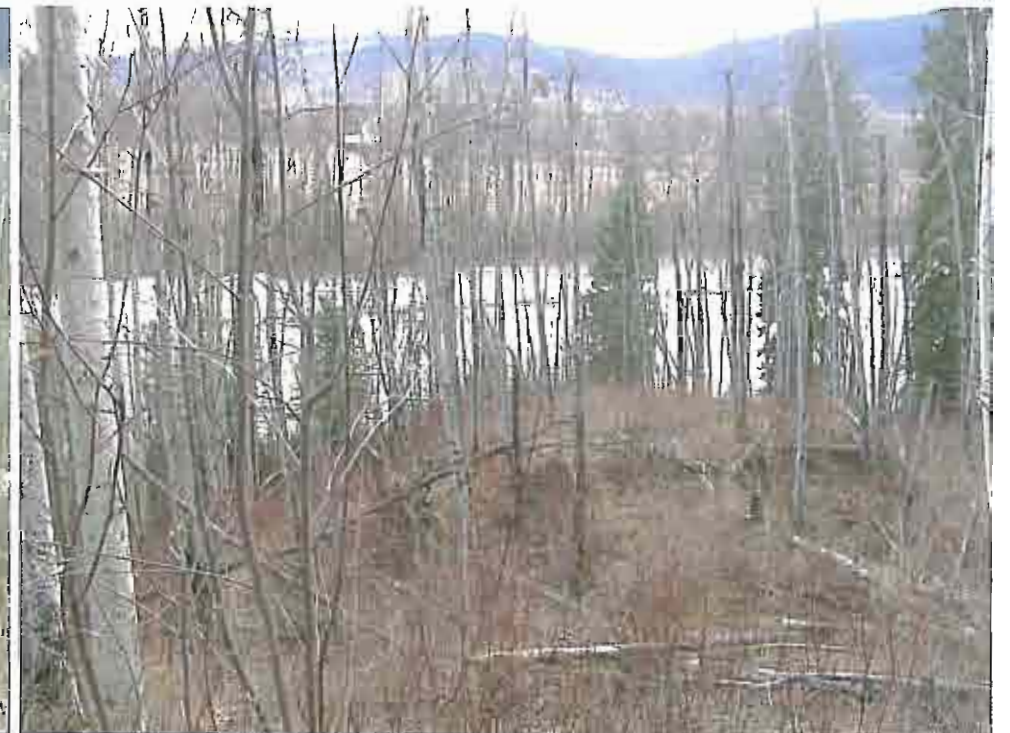
**Photo 34:** View south west at typical hummocky, ridged landslide terrain on slope below 355 to 485.

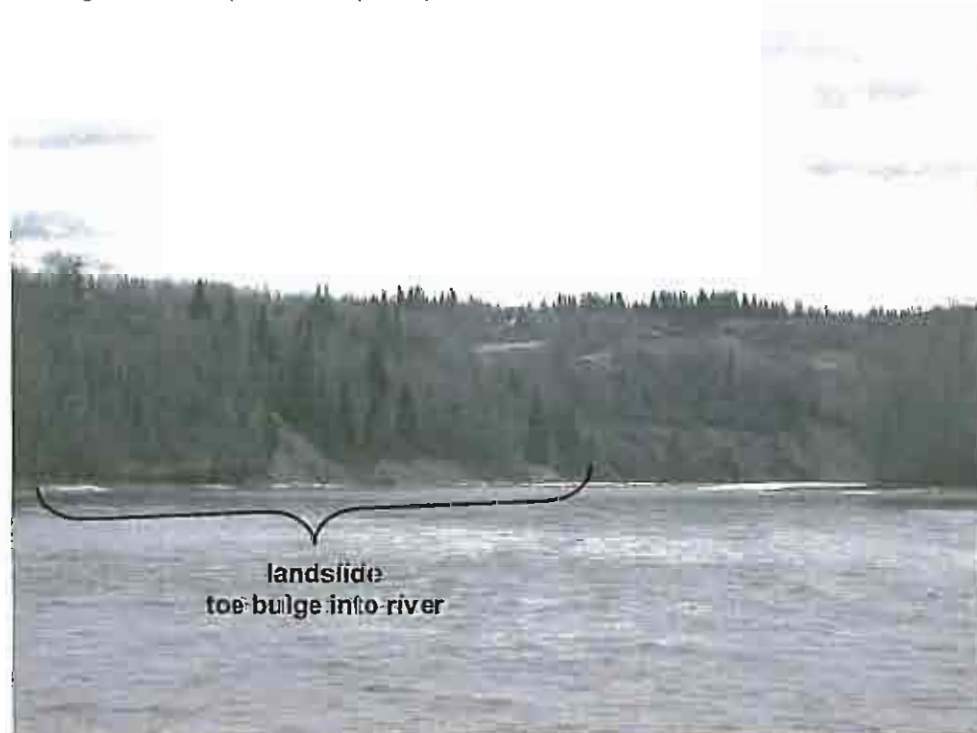
**Photo 35:** View upstream (east) along Bulkley River at landslide toe area along river bank (left half of photo).

landslide  
toe bulge into river

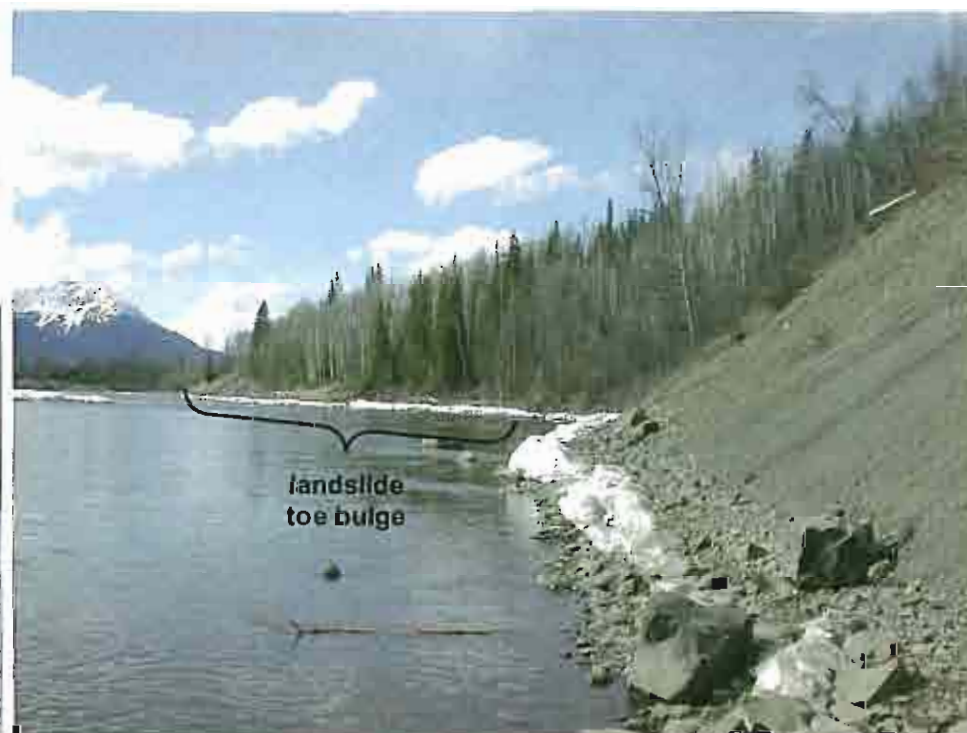
**Photo 36:** View downstream (north west) along Bulkley River at landslide toe area along river bank (just beyond steep uniform slope shown to right of photo).

landslide  
toe bulge

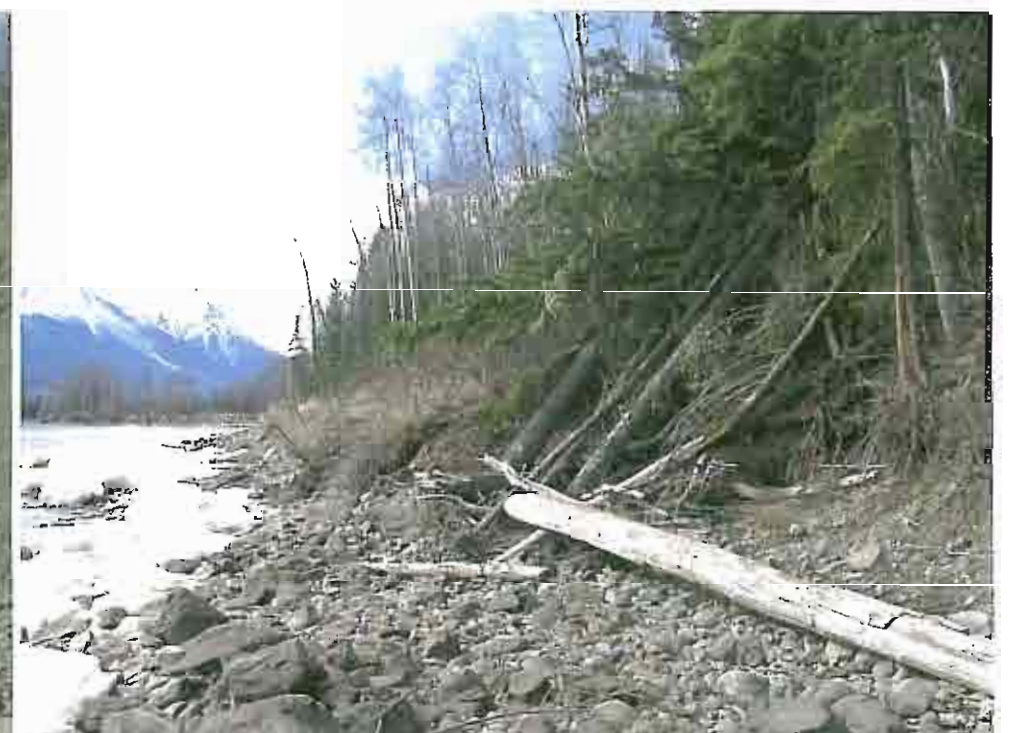
**Photo 37:** View downstream at typical distorted vegetation, irregular ground and eroded banks along toe of landslide.

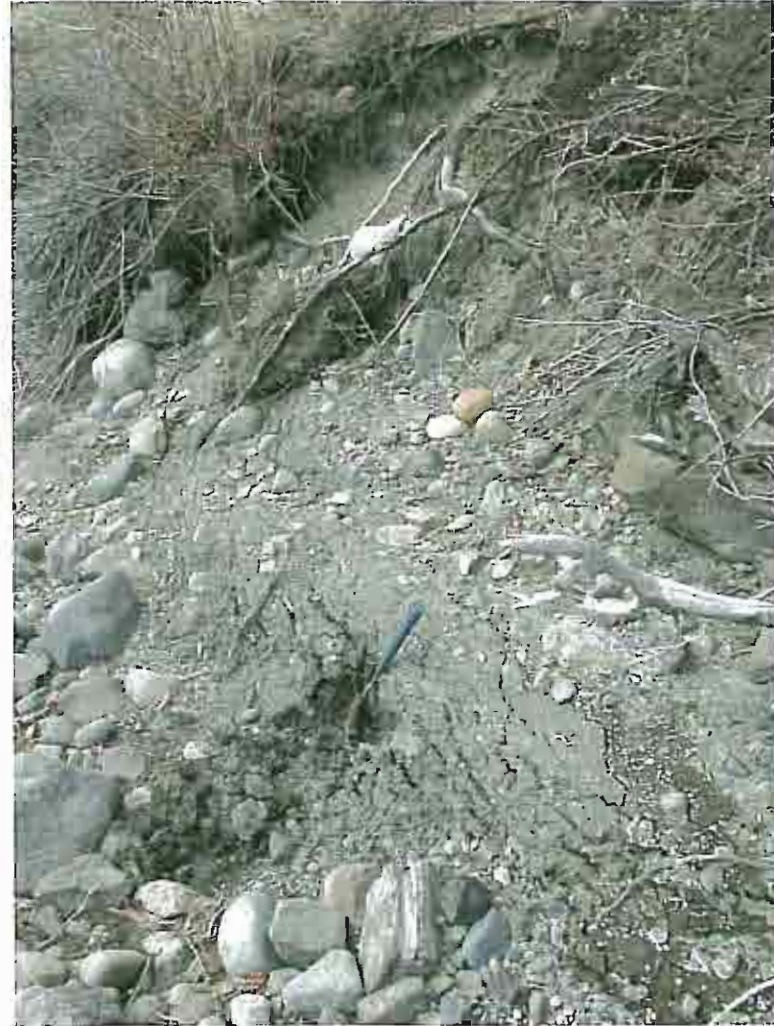
**Photo 38:** Close up of toe thrust ground movement along river bank, in soft, wet high plastic clays, below 195 Lower Viewmount Road.

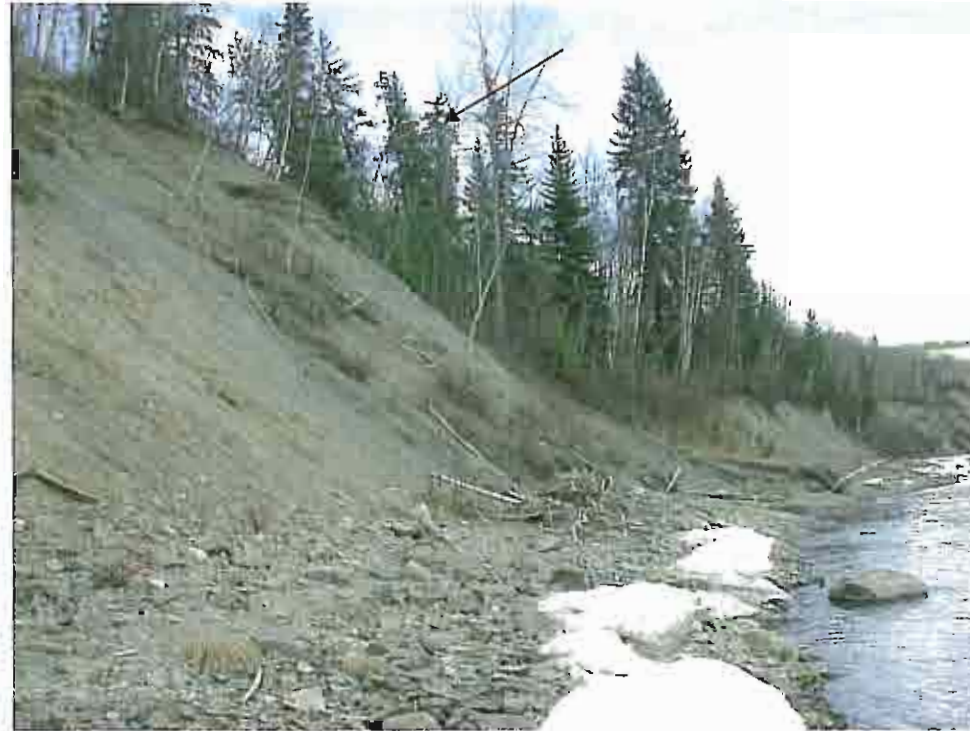
**Photo 39:** View upstream at toe thrust area along Bulkley River below 355 to 485 Lower Viewmount Road. Note eroded slopes and back tilted trees.

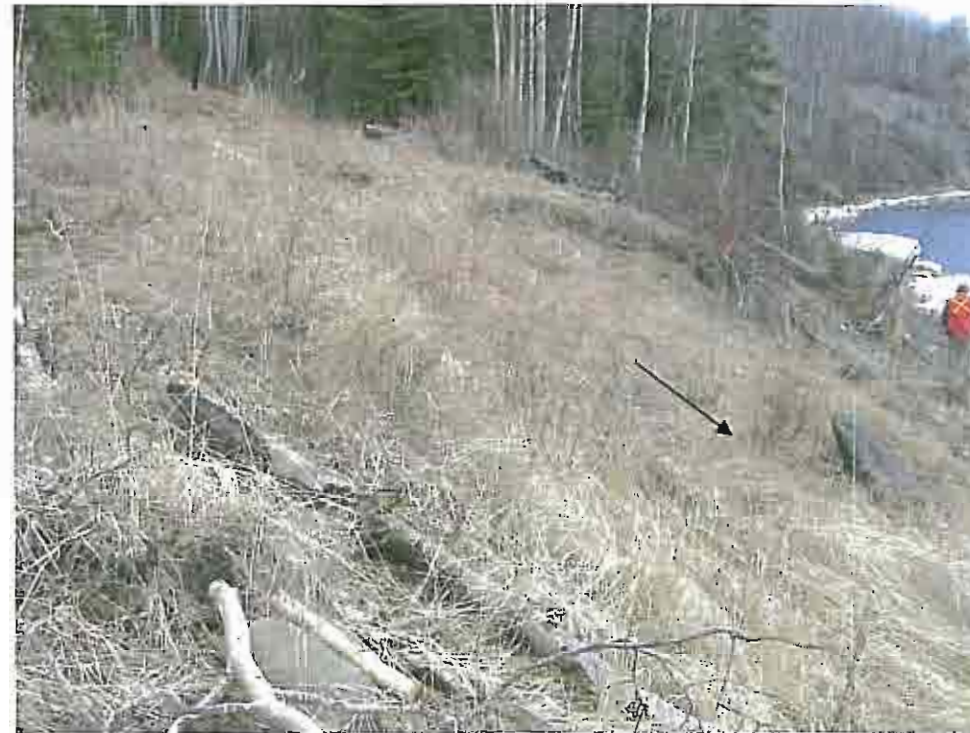
**Photo 40:** Evidence of recent ground movements along river bank below 265 Lower Viewmount Road.

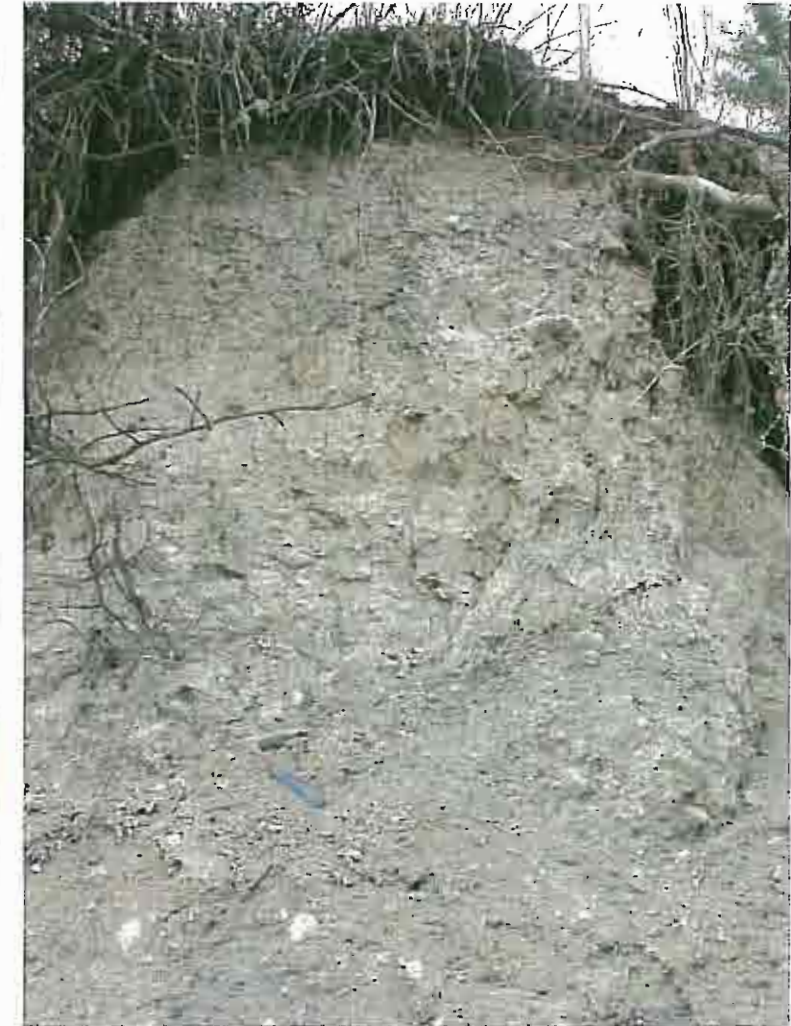
**Photo 41:** View of clay till exposure on displaced slide block exposed along river bank.

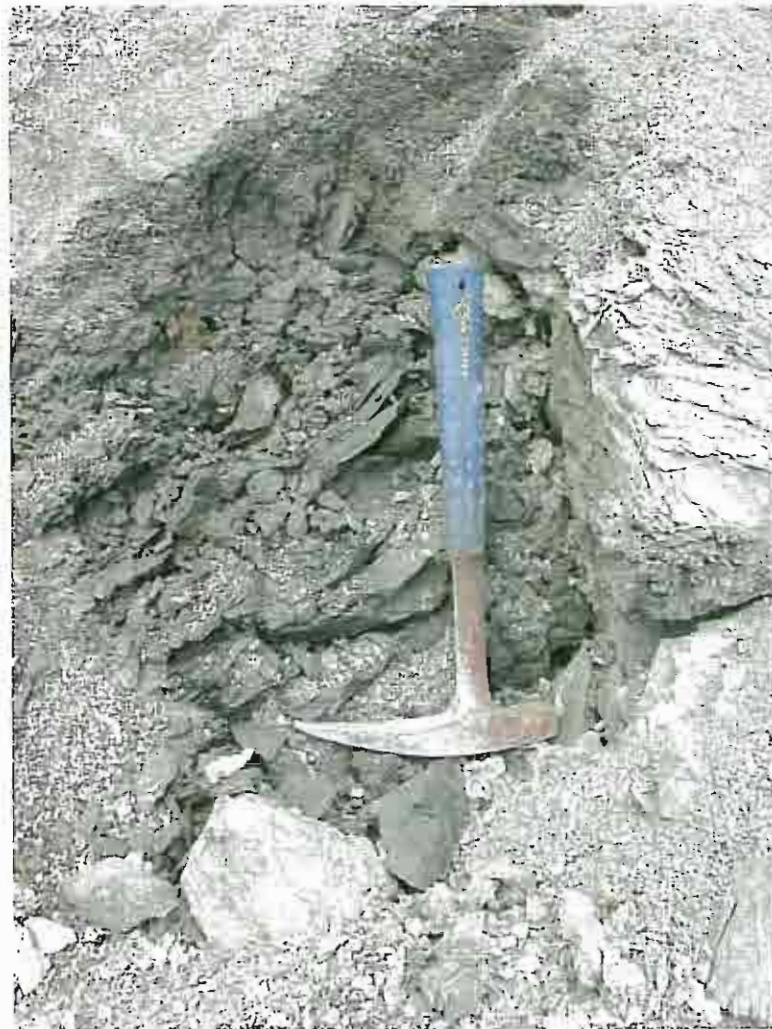
**Photo 42:** High plastic clay with some interbedded silt seams, exposed along river bank at toe of slope.

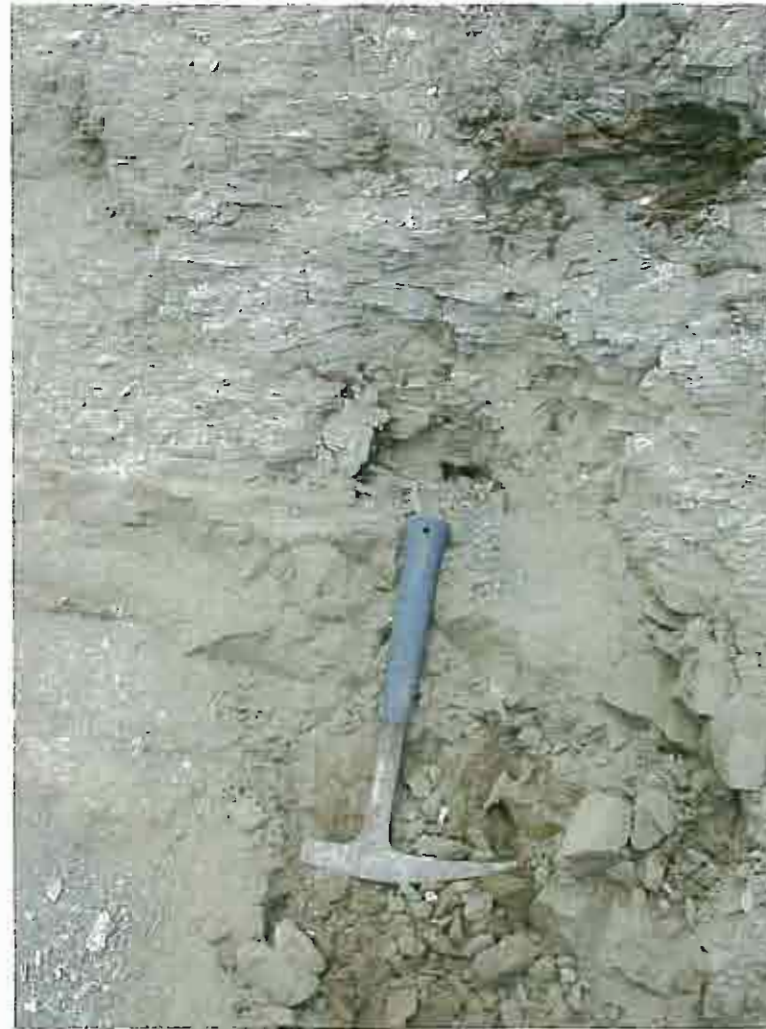
**Photo 43:** Silt and sand overlain by high plastic clay, exposed along river bank at toe of slope.

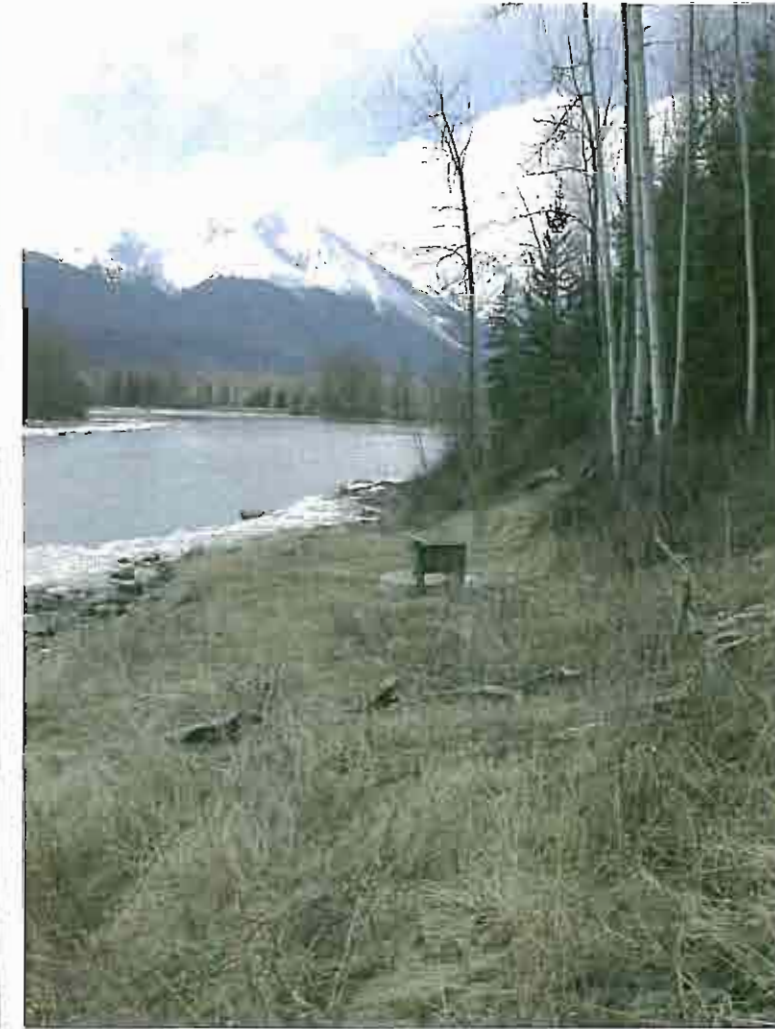
**Photo 44:** Local community well located on river bank at toe of slope below 265 Lower Viewmount Road.

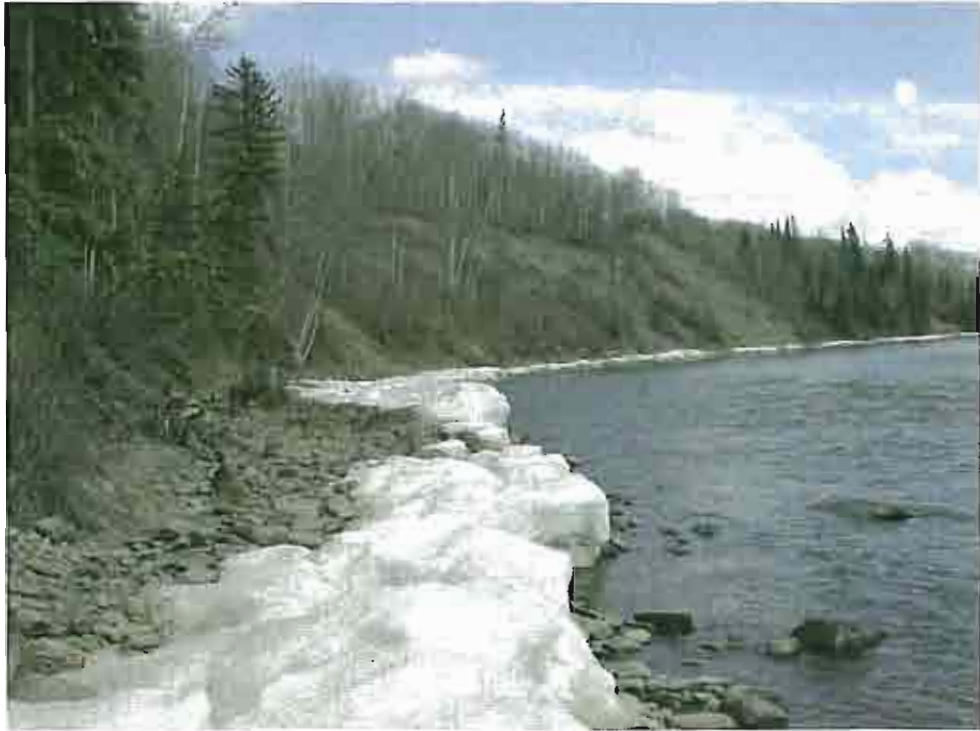
**Photo 45:** View upstream from toe of landslide area towards uniform erosion slope below Harris Auto Wrecking site.

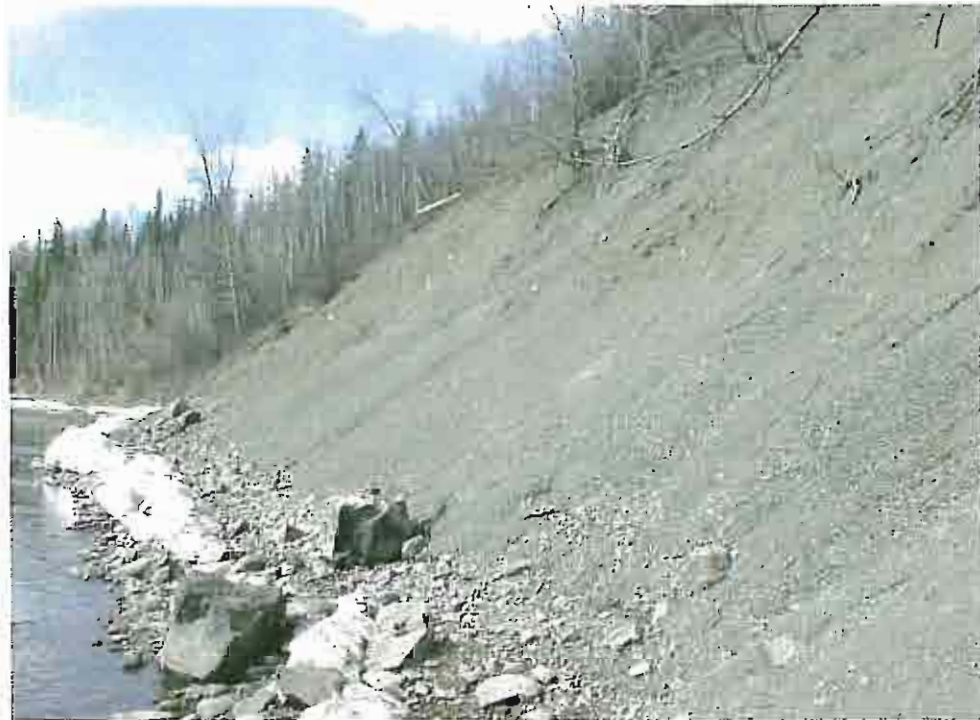
**Photo 46:** View downstream at steep eroded river valley slope below Harris Auto Wrecking site. Soil appeared to be colluvium derived from clay till with some sand and gravel, overlying bedrock.

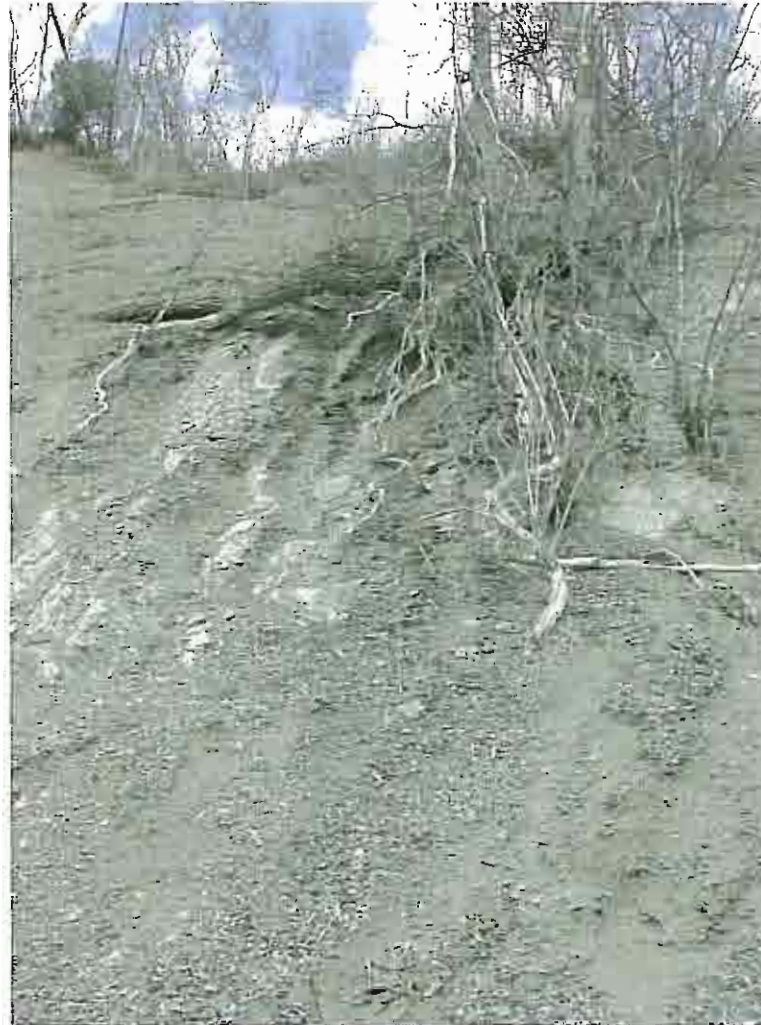
**Photo 47:** Bedrock outcrop on steep eroded slope below Harris Auto Wrecking site.

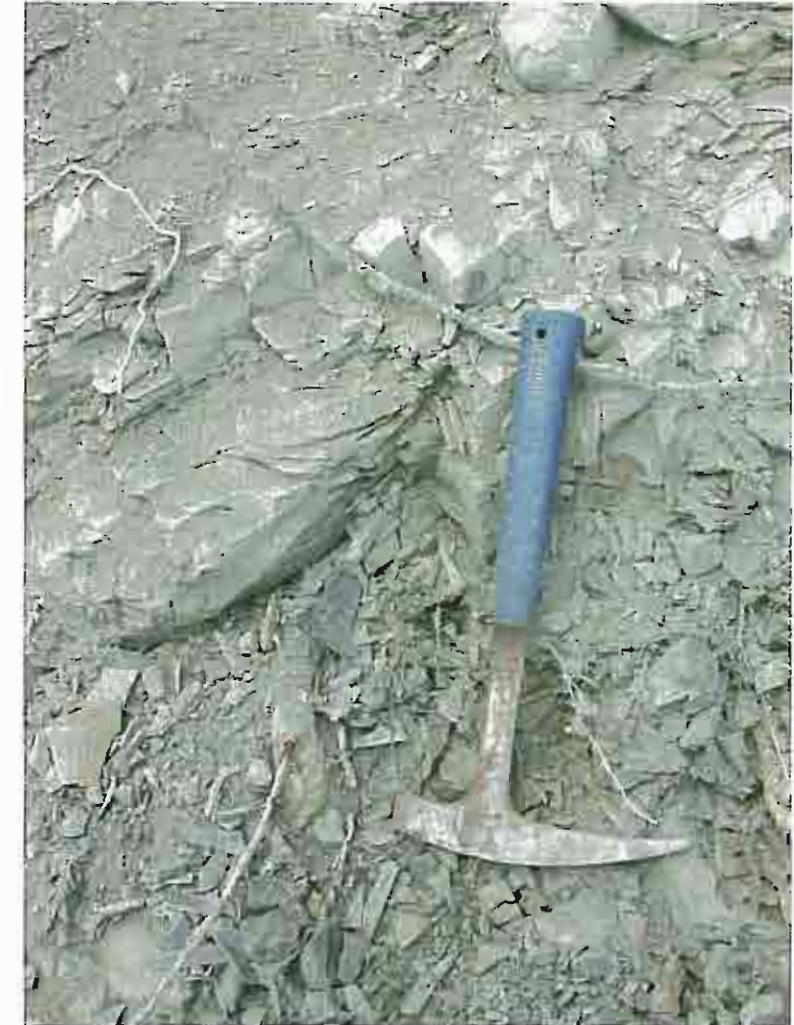
**Photo 48:** Close up of bedrock exposed on eroded slope below Harris Auto Wrecking site (dark grey siltstone and shale, dipping out of slope at approximately 30 degrees).

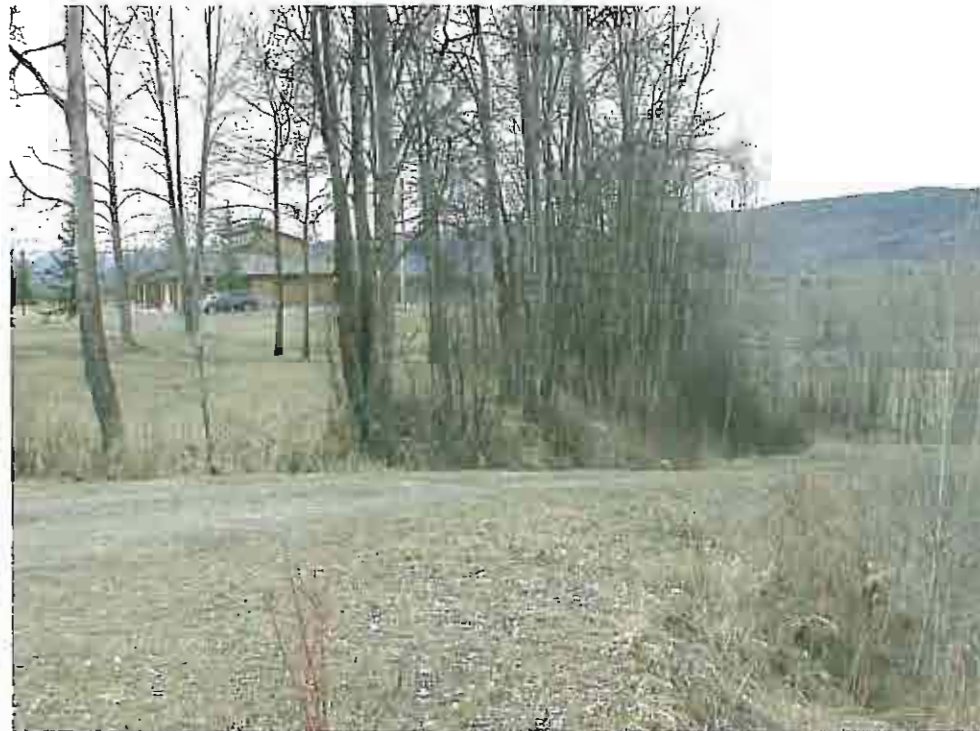
**Photo 49:** Looking south west at intersection of old access road down old river valley slope with Lower Viewmount Road, just north of 661.

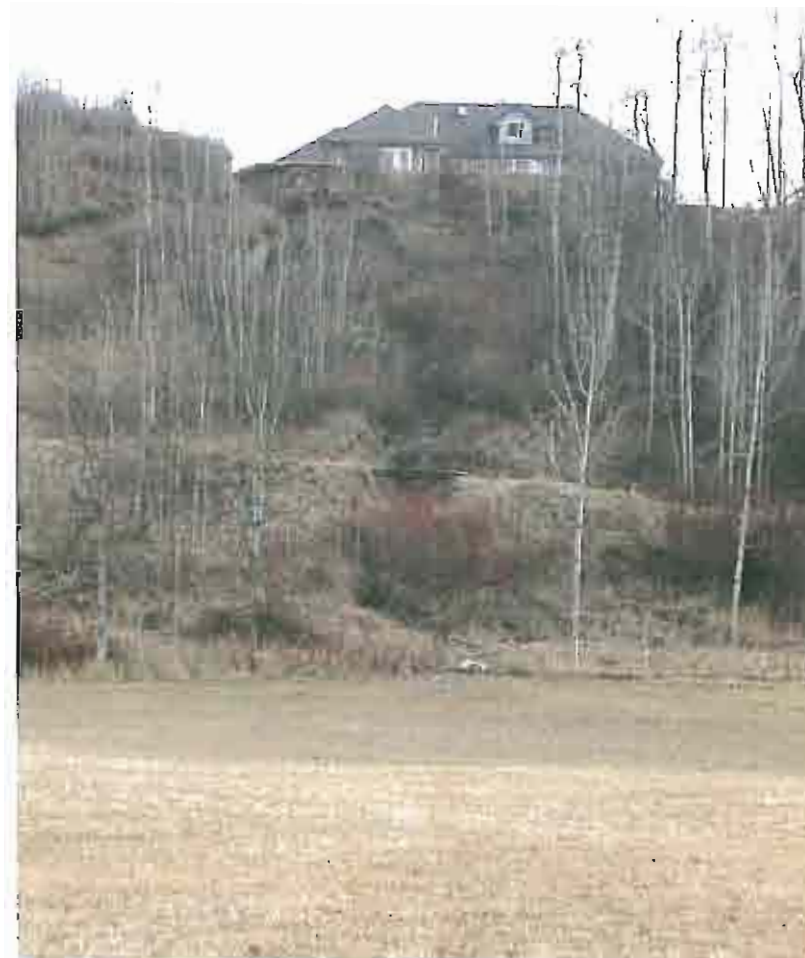
**Photo 52:** Looking north east at 559 and erosion gully down old river valley slope and across old access road.

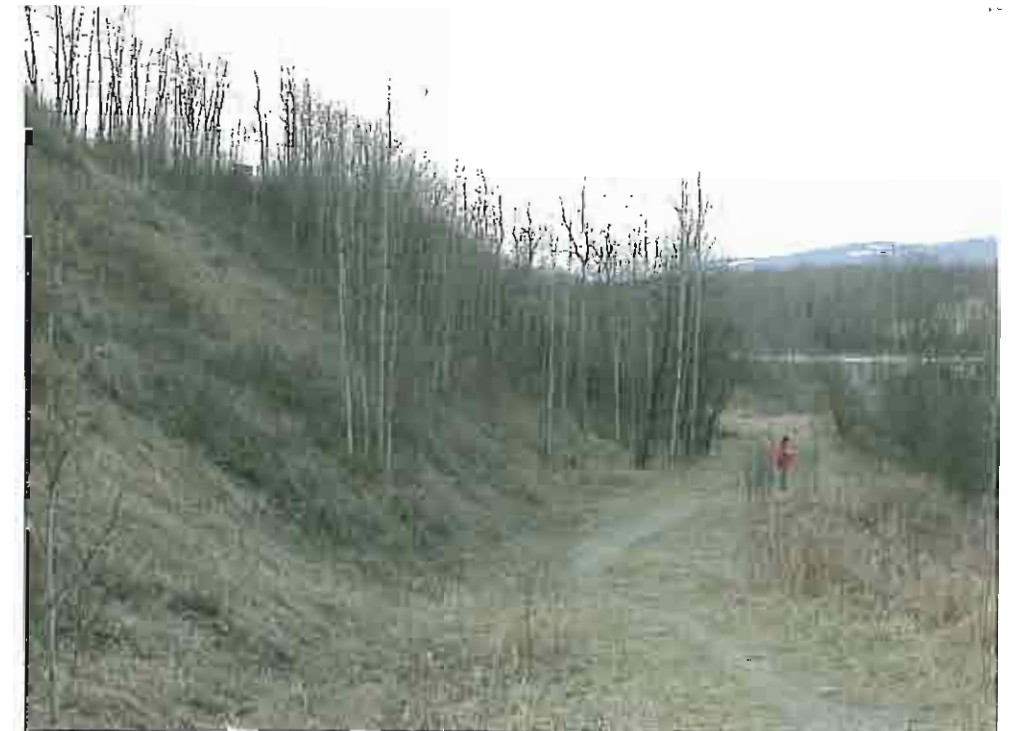
**Photo 50:** View south at old cuts and fills along old access road, on old river valley slope below 661.

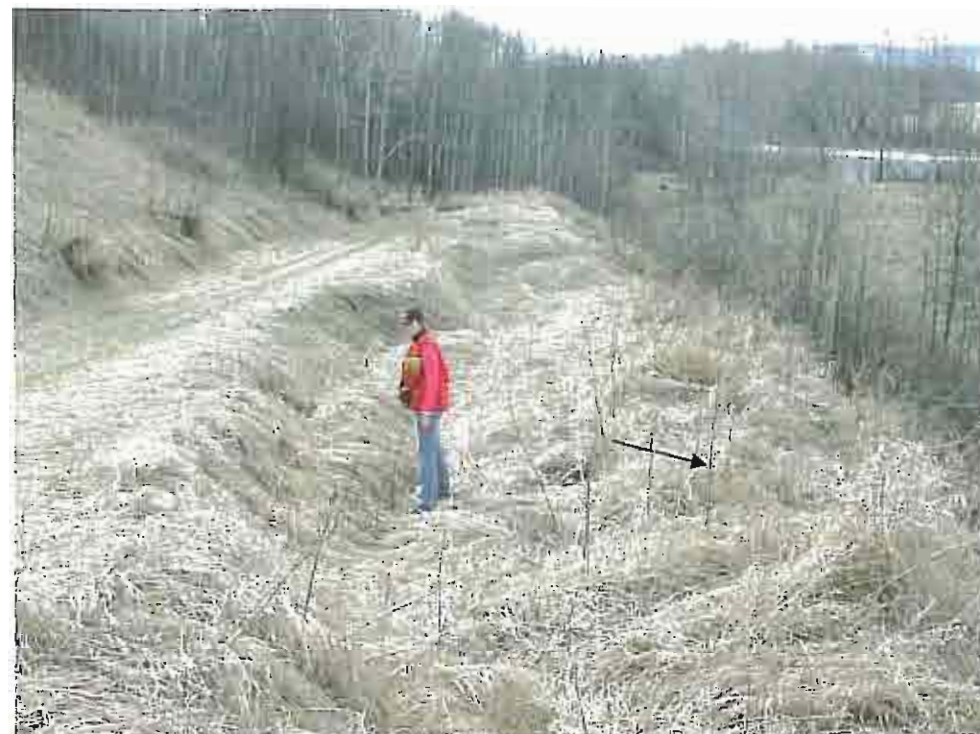
**Photo 51:** View south at fill failure on old access road, below 661.

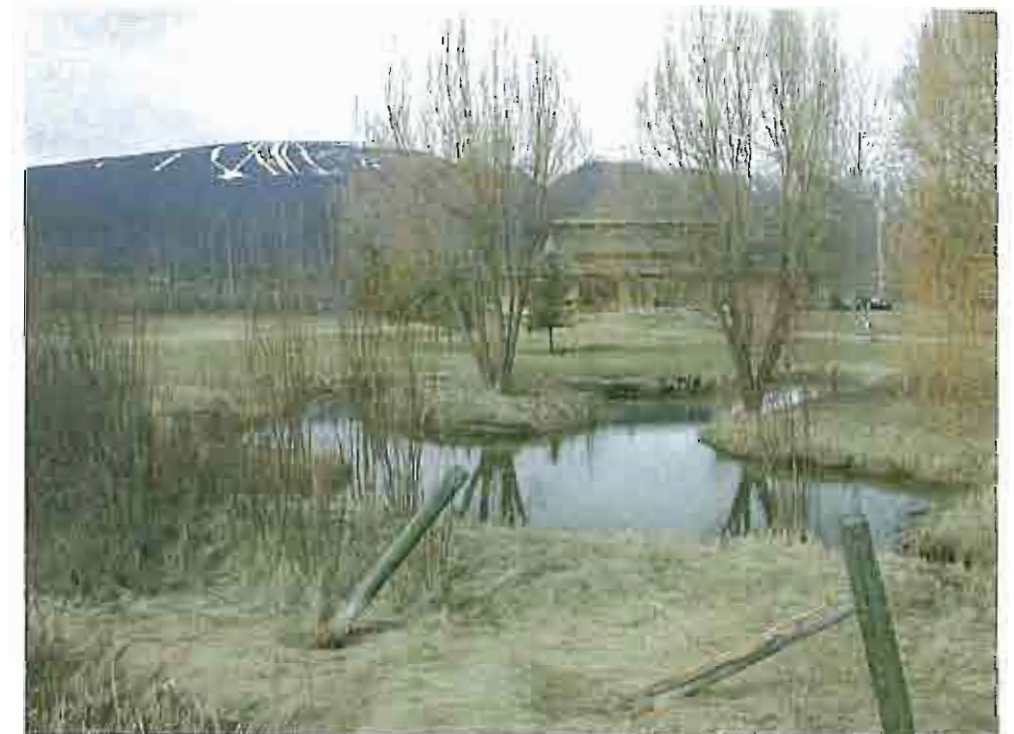
**Photo 53:** Drainage pond area above old valley slope between 559 and 661.

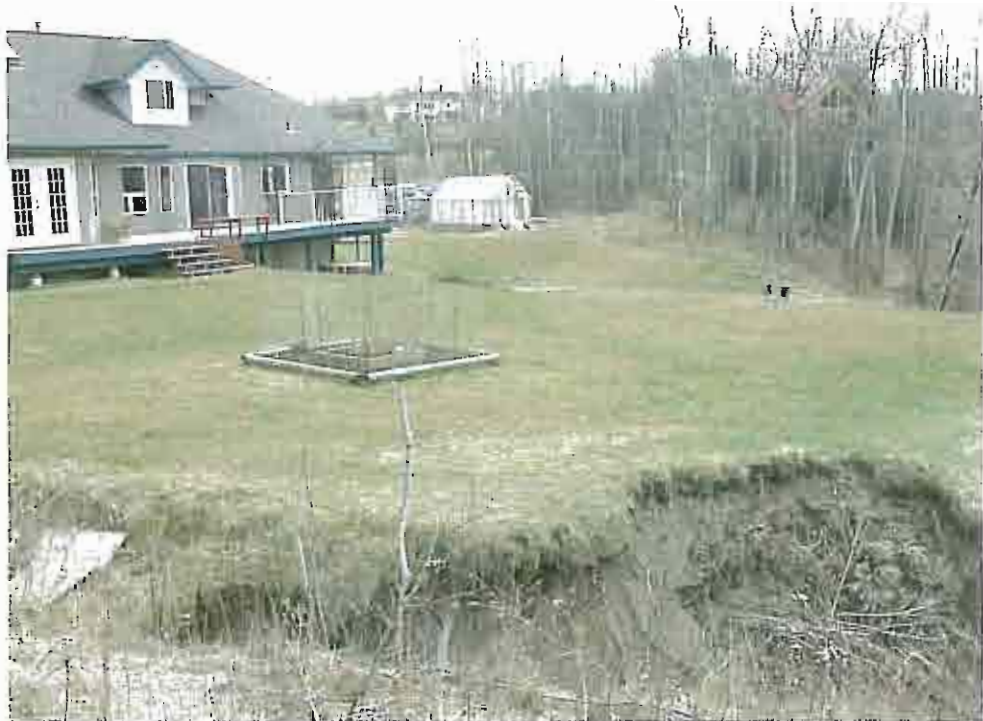
**Photo 54:** Erosion at crest of old river valley slope, behind 559. Drainage from pond area (Photo 53), enters from left foreground.

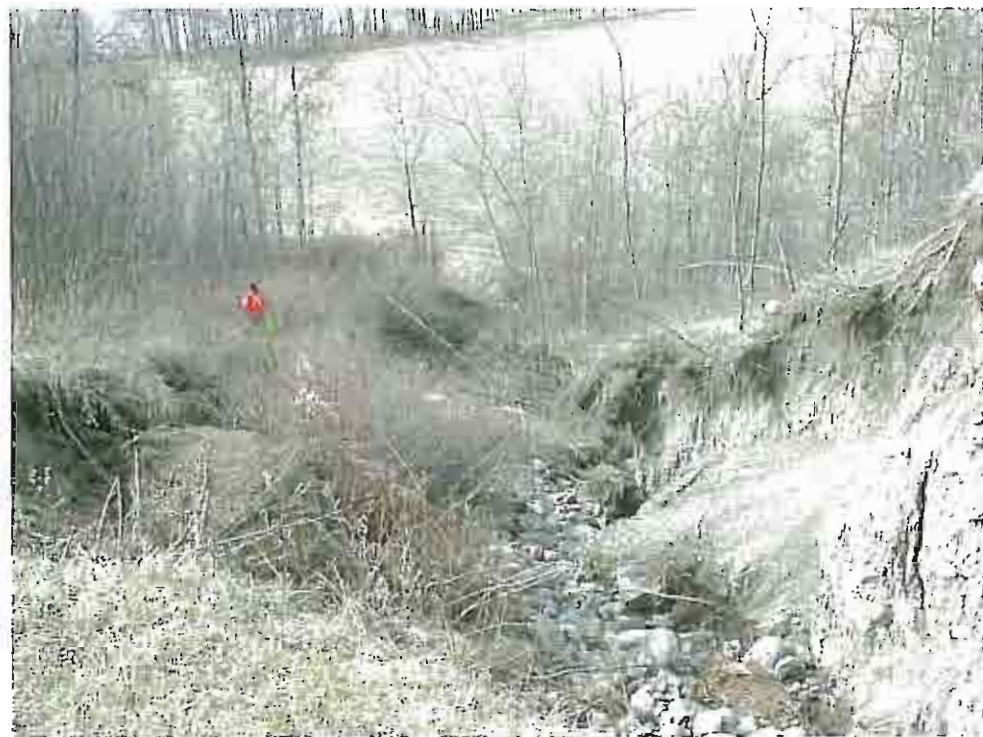
**Photo 55:** Looking down erosion gully from crest of slope at the rear of 559. Note recent sliding of undercut slopes.

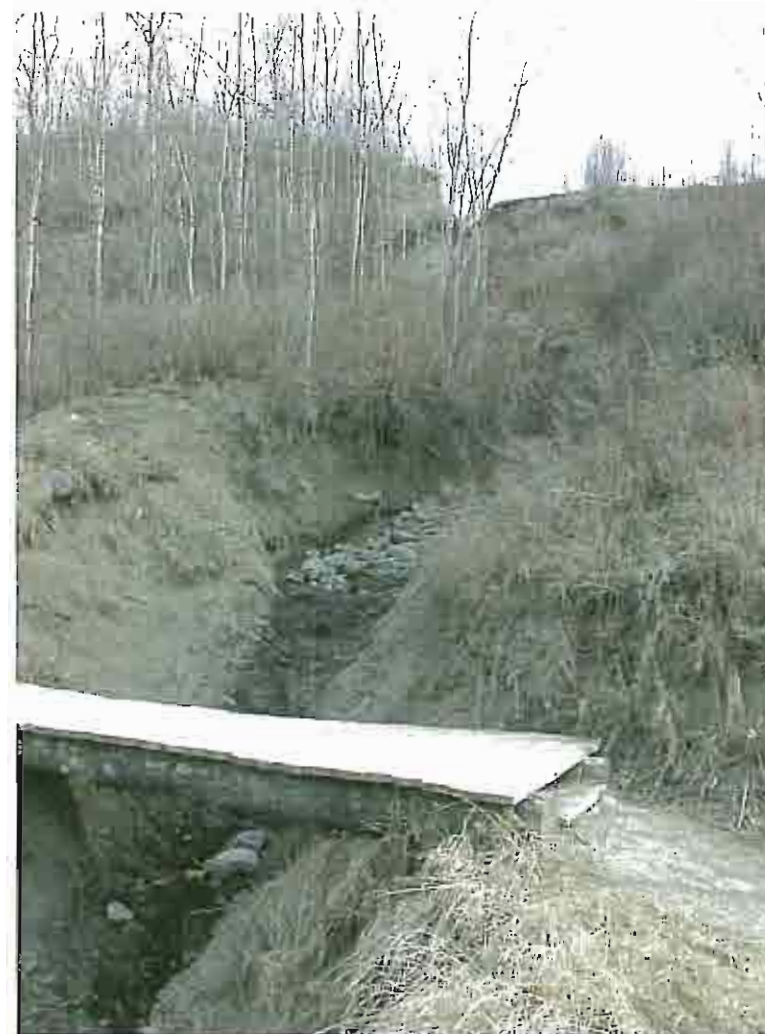
**Photo 56:** Looking upslope across old access road at erosion gully on slope below 559. Bedrock exposed in lower portion of gully.

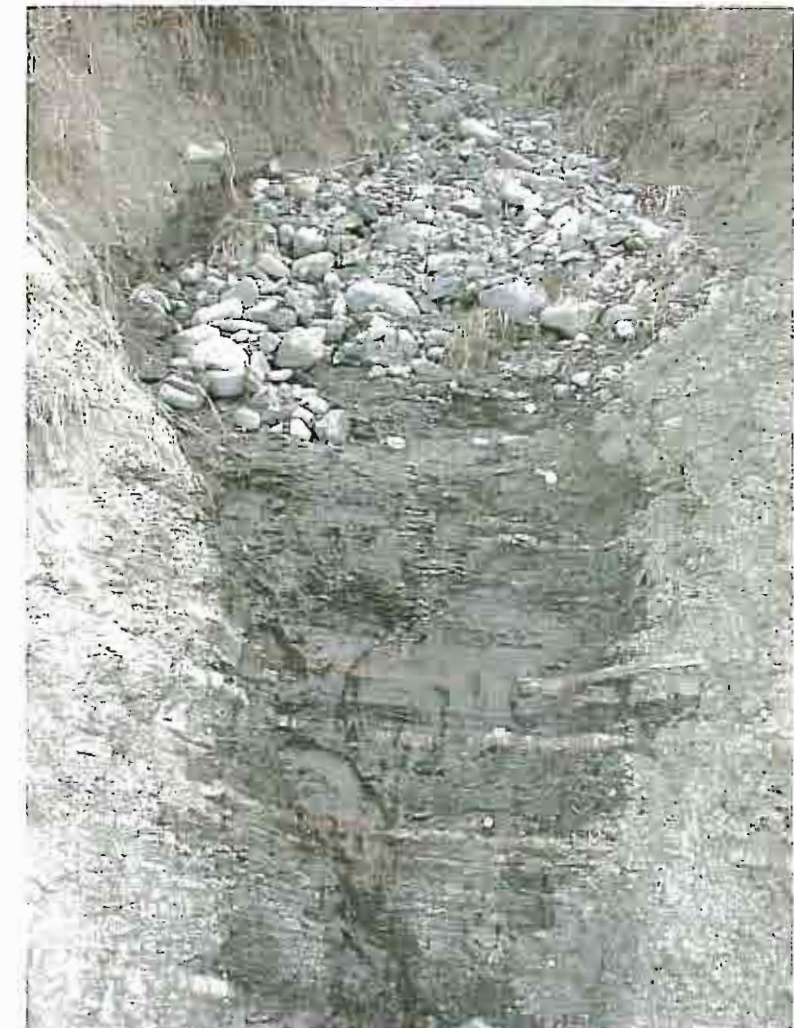
**Photo 57:** Bedrock (shale, siltstone, minor sandstone), exposed in erosion gully below 559 just above old access road.

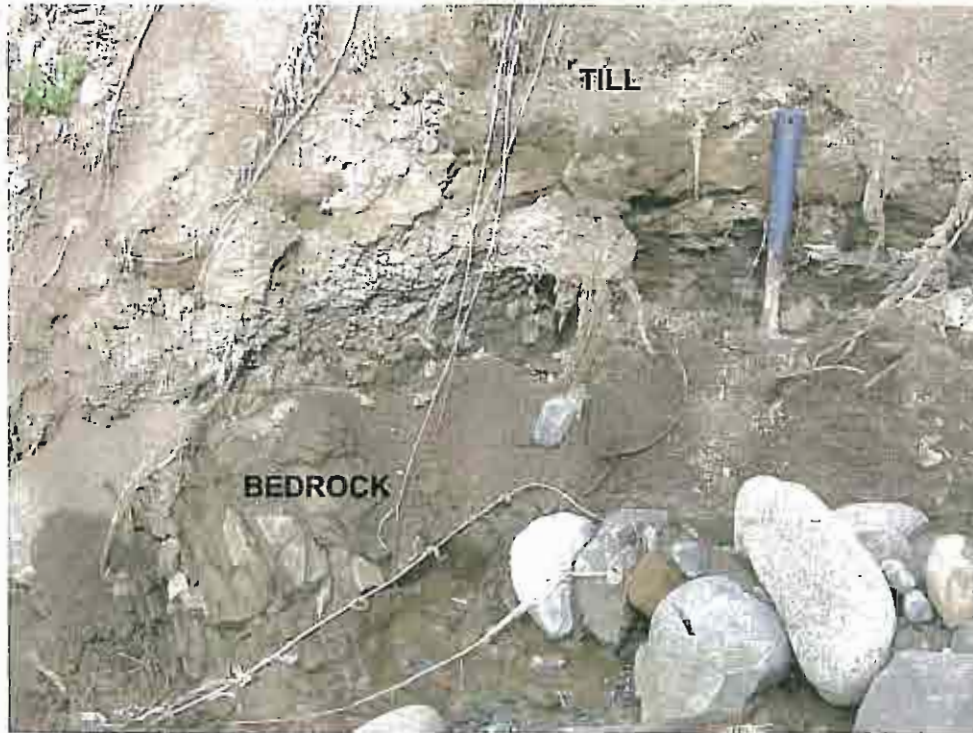
**Photo 58:** Close up of contact between clay till and underlying bedrock, exposed in erosion gully below 559.

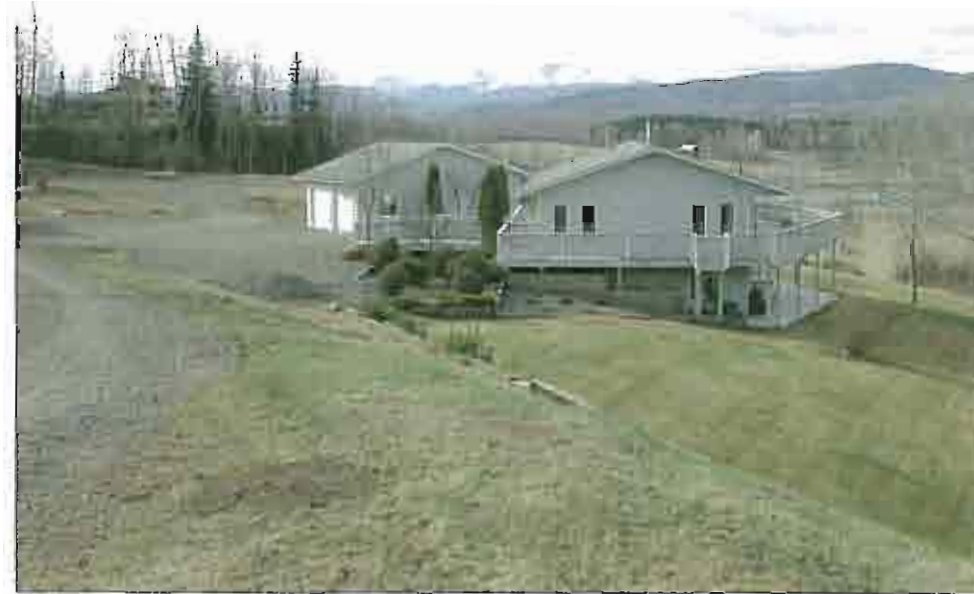
**Photo 59:** Typical cut and fill house site development on bench in old river valley slope (House at 825 looking south).

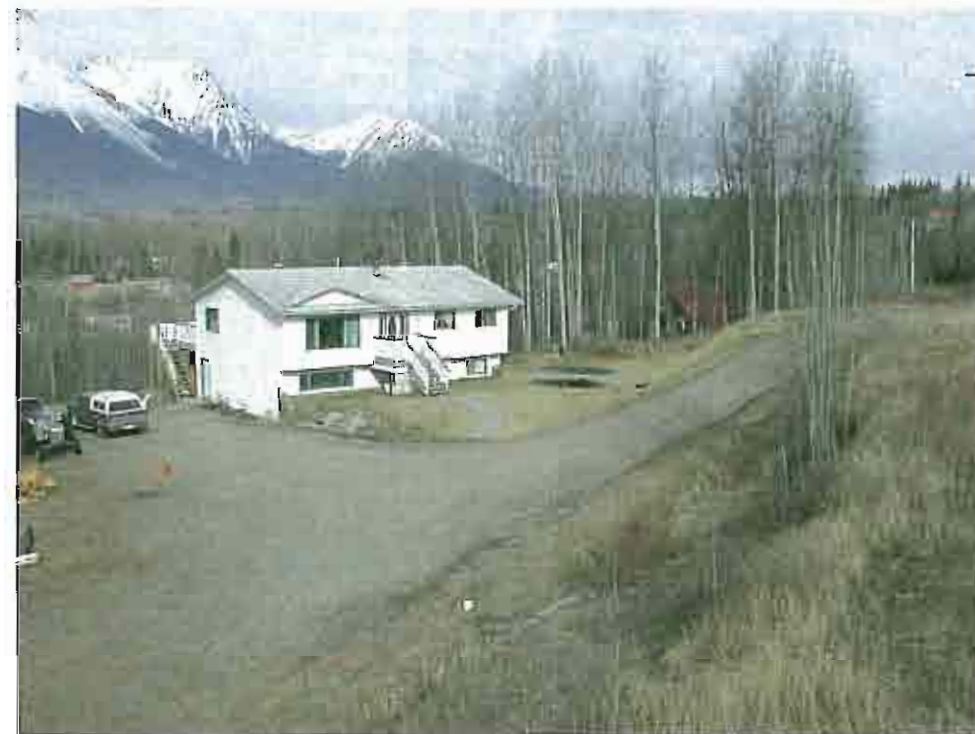
**Photo 60:** View west at cut and fill house site development on old river valley slope (House at 895).

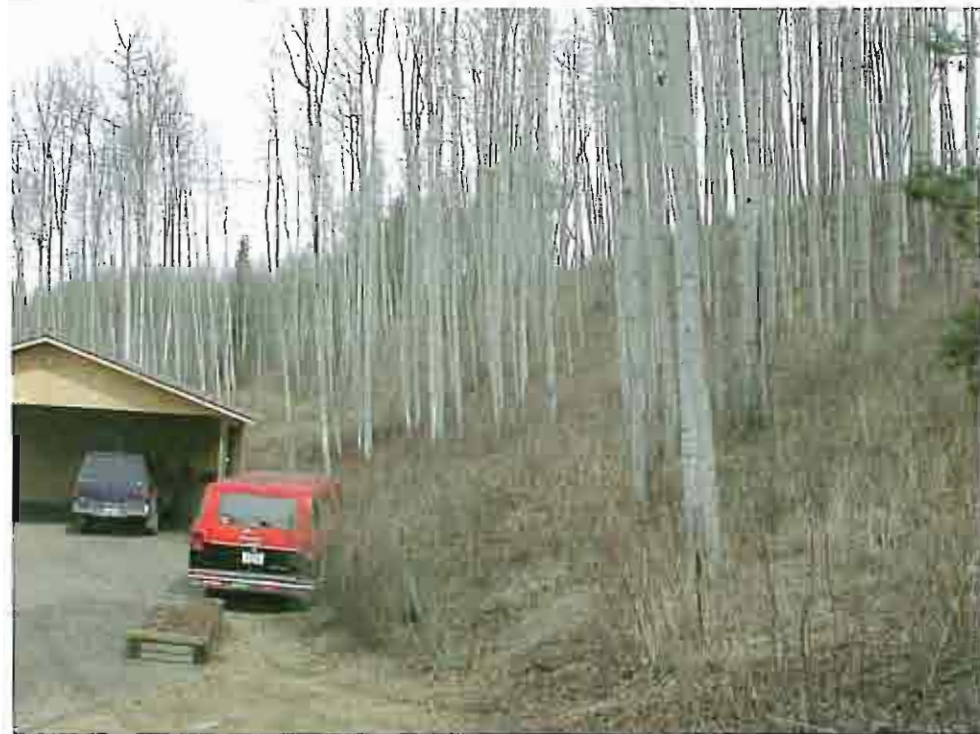
**Photo 61:** View north along uppermost portion of old river valley slope at rear (east side of 882).
