REGIONAL DISTRICT OF  
BULKLEY-NECHAKO

GEOTECHNICAL ASSESSMENT  
LOWER VIEWMOUNT ROAD  
SMITHERS, BC

DATE PREPARED: DECEMBER 2006

PROJECT No: KX04813

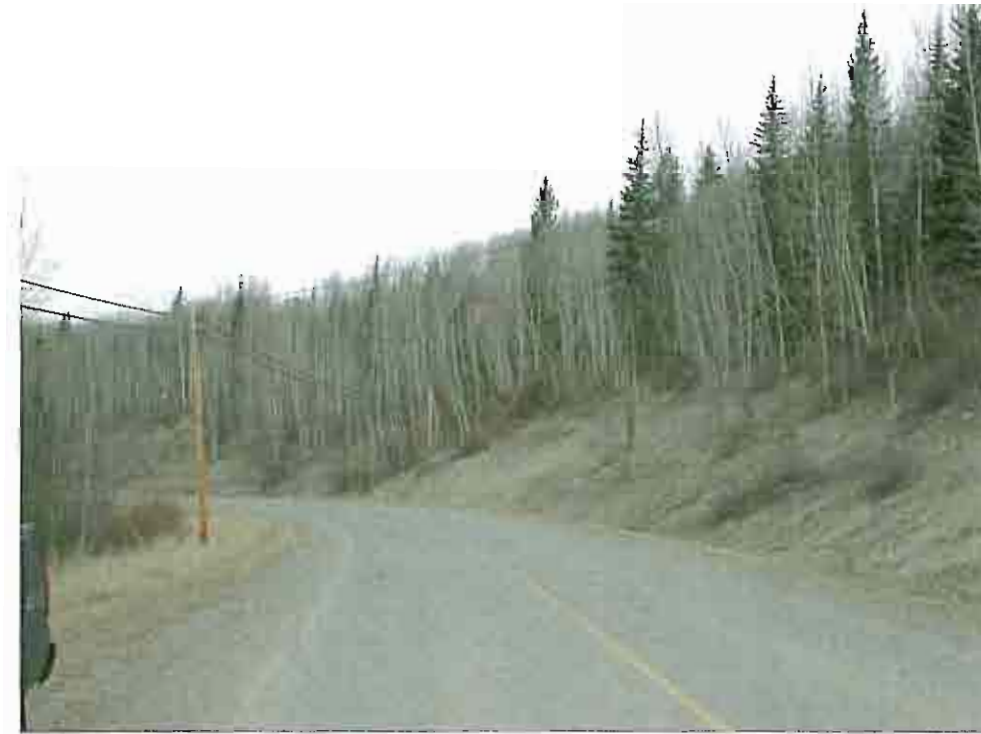
**Photo 62:** View north at cut slope on old Viewmount Road, subject to some surficial sliding, soil creep and erosion.

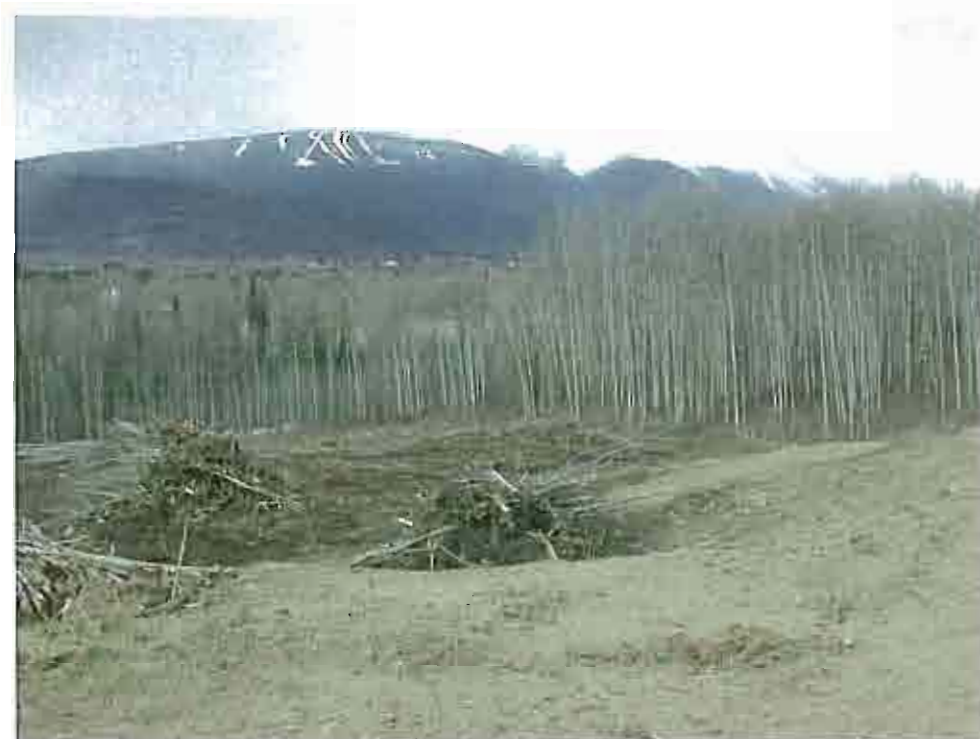
**Photo 63:** View west across recently cleared Lot 1 Plan 11141, located immediately south of Harris Auto Wrecking site.

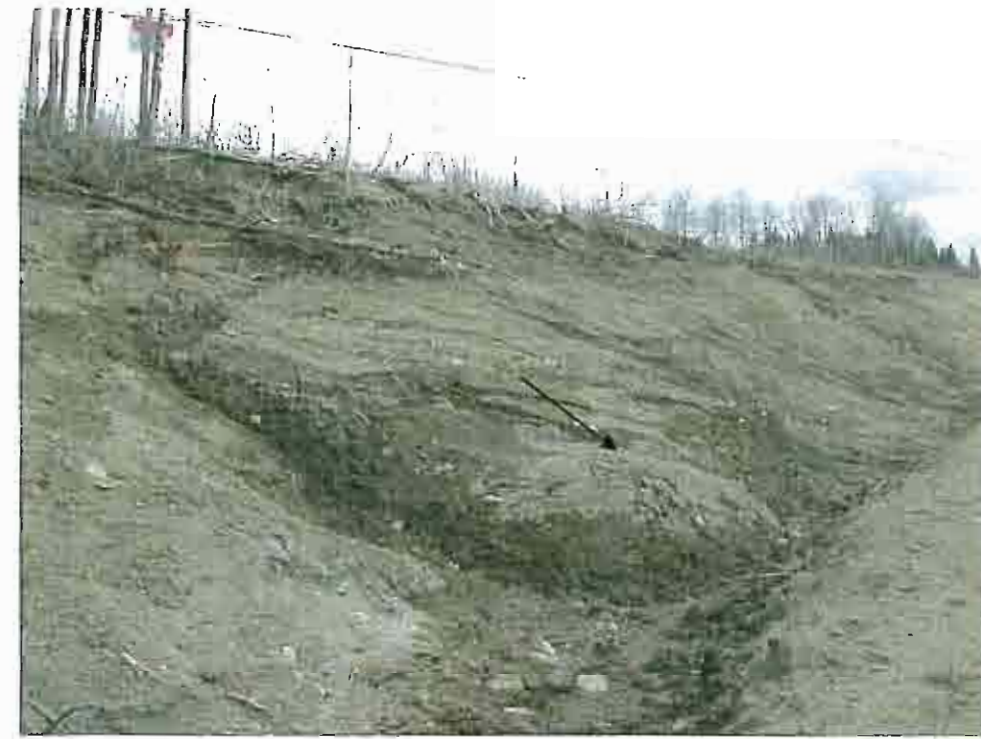
**Photo 64:** Failure of access road cut slope, constructed in wet, soft clay till soils at east side of Lot 1 Plan 11141.
