APPENDIX A

Figure 1	Location Plan
Figure 2	Site Plan - Topography
Figure 3	Airphoto Site Plan – Terrain Features
Figure 4	Airphoto Site Plan – Landslide Features (Study Area A)
Figure 5	Typical Sections (Assumed Geology)
Table A	Property Observation Summary

TITLE	LOCATION PLAN
PROJECT	GEOTECHNICAL ASSESSMENT LOWER VIEWMOUNT ROAD SMITHERS, BC

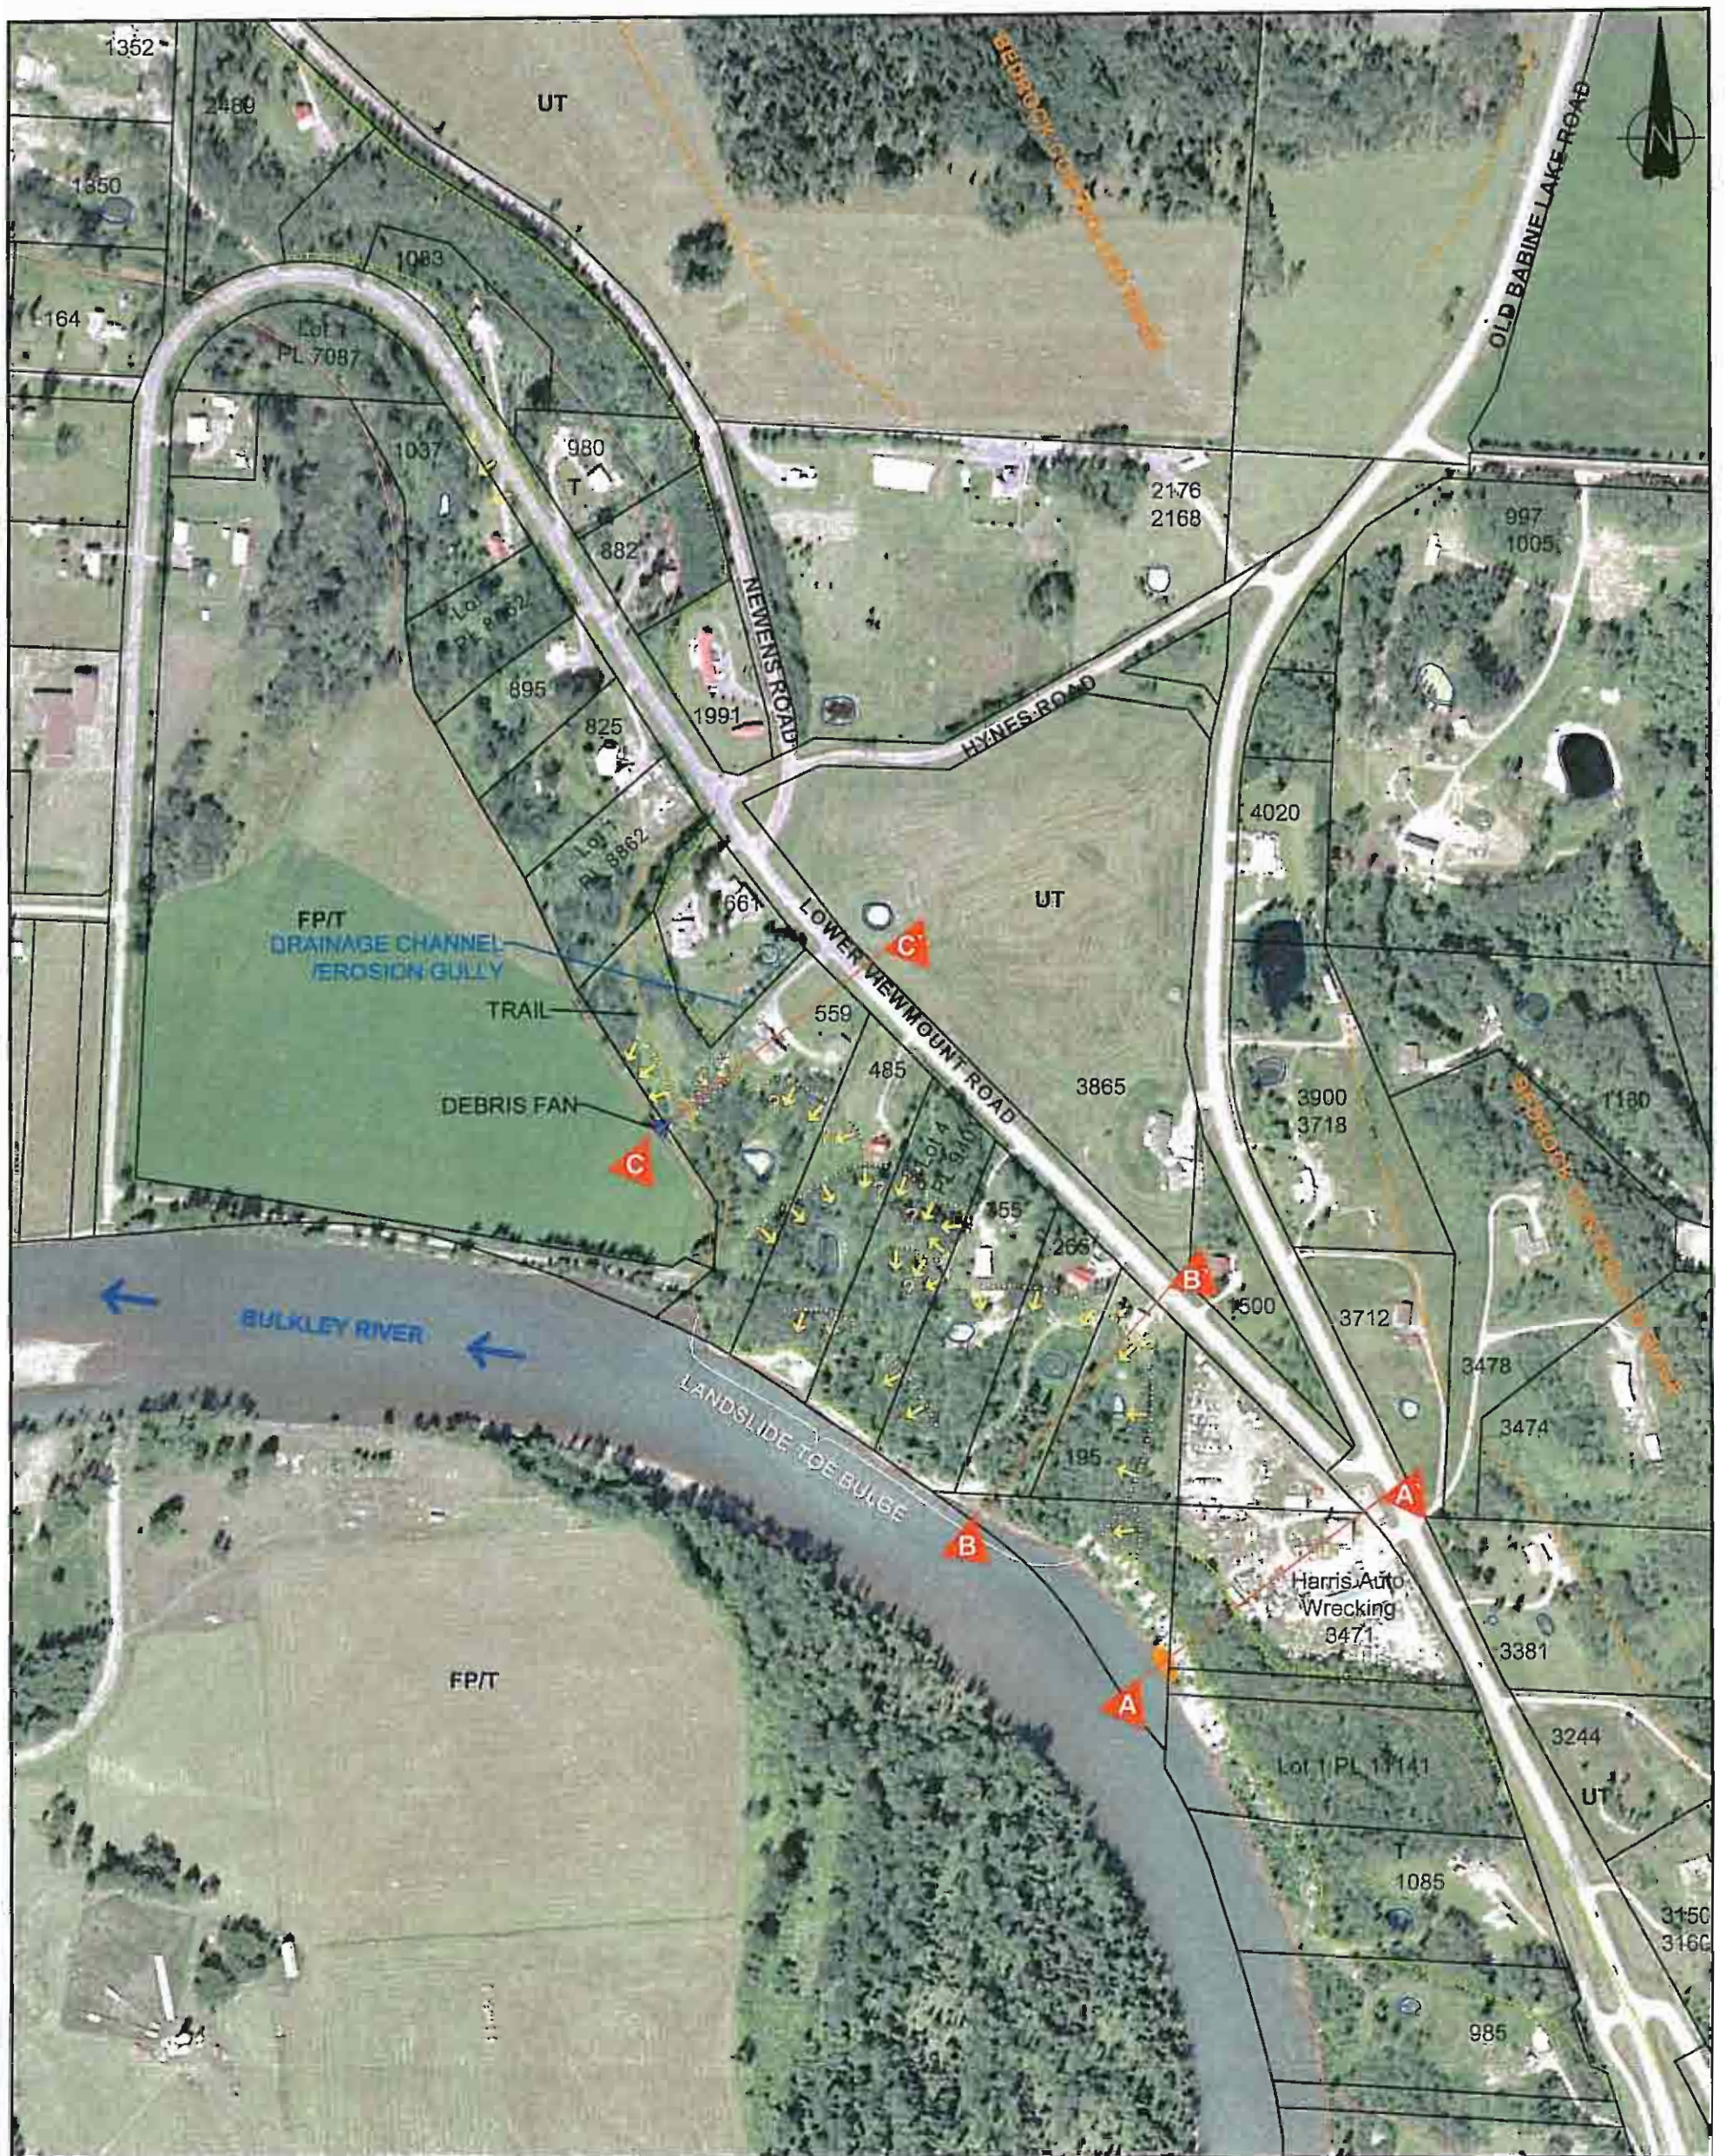
REV. NO.: A
DATE: DECEMBER 2006
PROJECT NO: KX04813
FIGURE No. **FIGURE 4**

TITLE
LANDSLIDE FEATURES
